Inspection Report

Sample Report

Closer Look Home Inspectors, L.L.C.

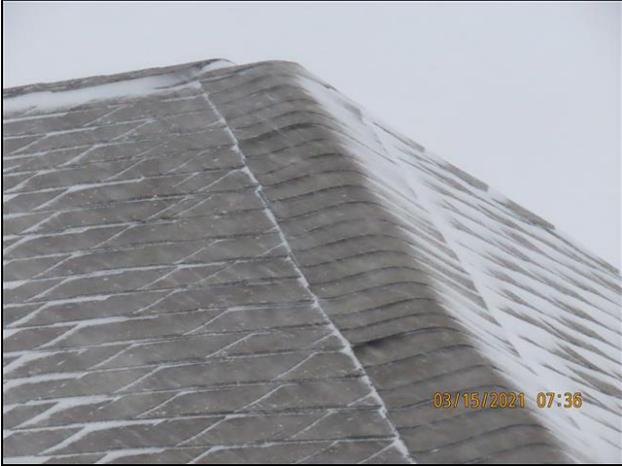
1.0 Item 1(Picture)

(2) At time of inspection, most if not all of the shingles at roof were covered with snow. Removing snow from roof goes beyond the scope of an inspection. Recommend further evaluation once snow covering has melted. Inspector disclaims knowledge of the shingles condition.

- Inspector observed what appeared to be to lifted shingles at the rear of home. Inspector recommends further evaluation once snow melts. This is indication maintenance or repairs may be needed in areas.
- Ensuring shingles are in proper condition will reduce chance of future moisture.

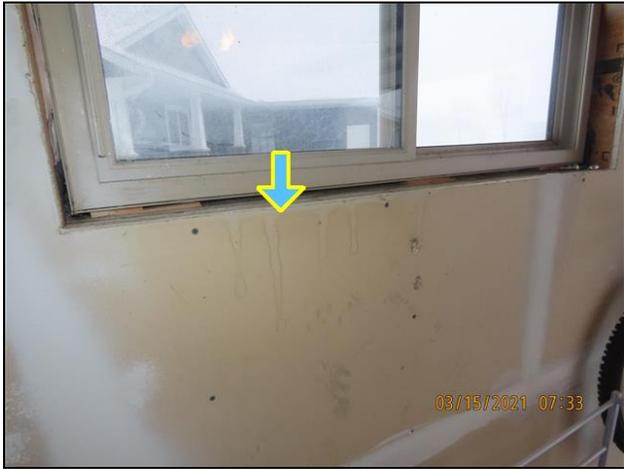
3.2 Item 1(Picture)

Inspector observed small localized areas of what appeared to be moisture stains. These areas were dry at time of inspection. Recommend monitoring, if moisture exists in the future further evaluation would be needed by a qualified contractor.

- Small amount of moisture under garage window
- Past moisture stain(s) near conventional door, leading to exterior of home.

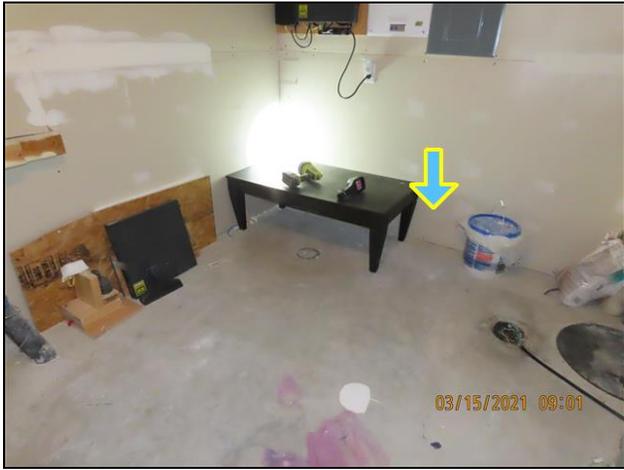
5.4 Item 1(Picture)

Inspector observed what appeared to be a moisture stain at the basement utility room in localized area. Determining past or intermittent moisture goes beyond the scope of a home inspection. You may wish to ask seller about this finding, monitored during heavy rainfall, or have a qualified contractor further evaluate as needed.

- This area was dry at time of inspection.

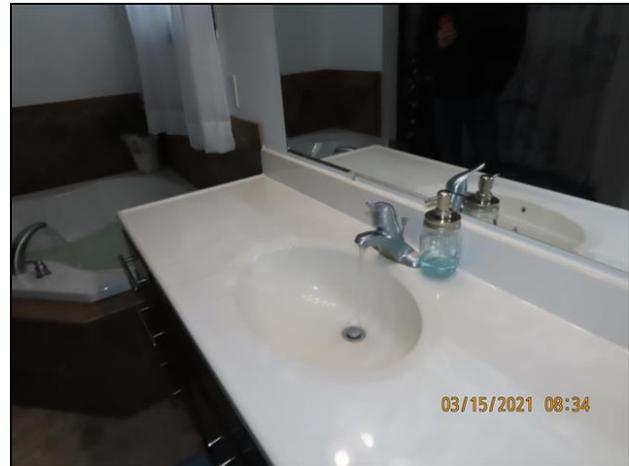
- When the upstairs master bathroom jet tub water source was turned ON.

6.2 Item 2(Picture) upstairs master bathroom sink - low water pressure when master bathroom jet tub water source was turned ON.

Determining exact cause goes beyond the scope of a home inspection. You may wish to have a qualified plumber further evaluate as desired.

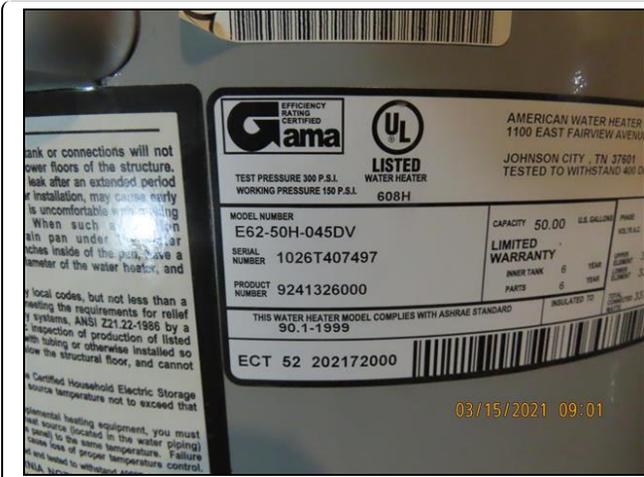
6.3 Item 1(Picture)

(1) The EPA (Environmental Protection Agency) recommends setting your water heater at 120 degrees to prevent burns.

- Current water temp 110F - increase to 120F or as needed
- Water heater Manufacture date appears to be 2010: <https://www.building-center.org/a-o-smith-water-heater-age/>
- Water heaters can be expected to last as long as the listed warranty.

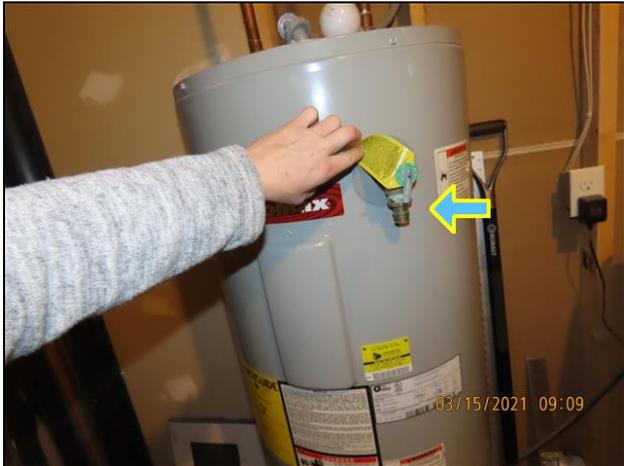
6.3 Item 2(Picture)

(2) The temperature/pressure relief (TPR) valve had no discharge pipe installed. If the valve were to activate while a person was nearby, injury could occur. The Inspector recommends that a properly-configured TPR discharge pipe be installed by a qualified plumbing contractor. The TPR VALVE SHOULD NOT BE TESTED UNTIL A PROPER DISCHARGE PIPE HAS BEEN INSTALLED.

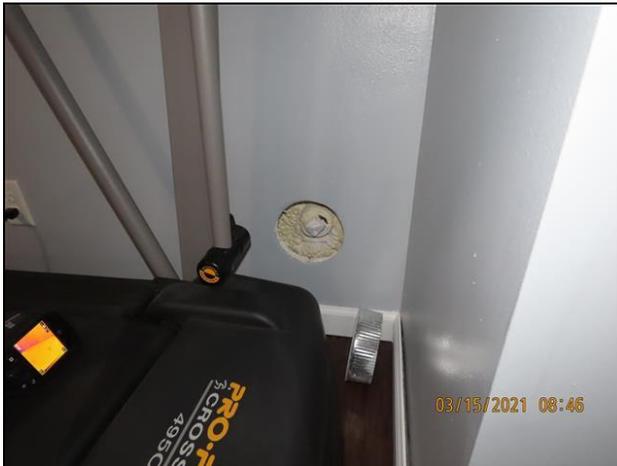
6.7 Item 1(Picture)

(2) The main waste supply pipe appeared to be located at the basement wall, behind access cover.

- The PVC cap appeared to be sealed shut with foam insulation. Inspector recommends ensuring the cap is accessible as needed. This is a general maintenance item. Replacement caps can be purchased for under \$10 if needed.

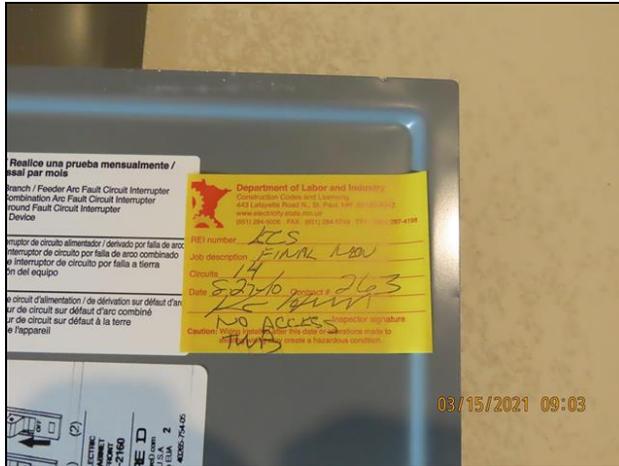
7.0 Item 1(Picture)

- Item 1(Picture) appears to have been last inspected in 2010. The home contained an electrical system which was last inspected more then 10 years ago.
- No visible evidence of fire damage or scorching visible.

Because of the potential for hidden defects and the specialized knowledge needed to adequately inspect electrical systems, you may wish to have a comprehensive inspection of the entire electrical system by a qualified electrical contractor.

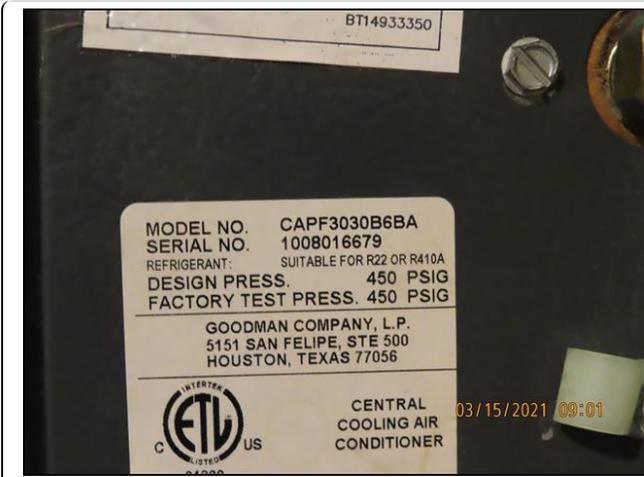
8.0 Item 1(Picture)

- Manufacture date appears to be 2010.
- Determining remaining life span goes beyond the scope of a home inspection.
- The furnace appeared to be working under normal operation at time of inspection (using thermostat)
- You may wish to consider purchasing a home warranty or obtaining information about long term service plans to ensure the furnace remains in its best working order. Long-term service plans are available through local energy companies. Recommend asking your realtor about options as desired.
- All gas appliances should be maintained annually or as needed.

Inspector recommends having a qualified HVAC technician clean furnace and supporting duct work to increase life span of furnace and promote healthy living conditions every 2-3 years or as needed.. General cost is \$300-\$500 and is considered general maintenance.

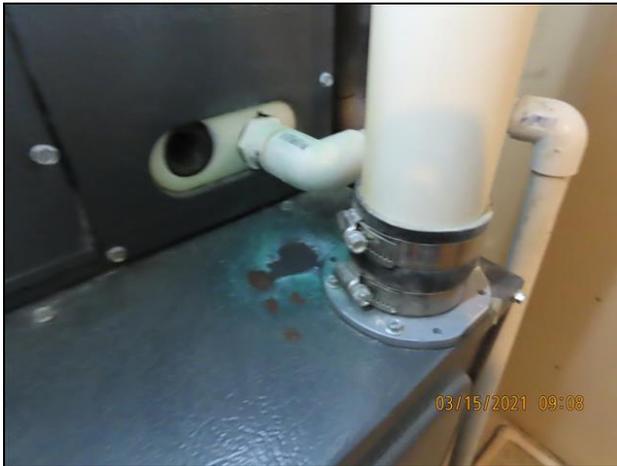
8.0 Item 2(Picture)

(2) Inspector observed what appeared to be past moisture at or near the furnace. These areas were dry at time of inspection. You may wish to ask seller about this finding. Determining past or intermittent moisture goes beyond the scope of a home inspection.

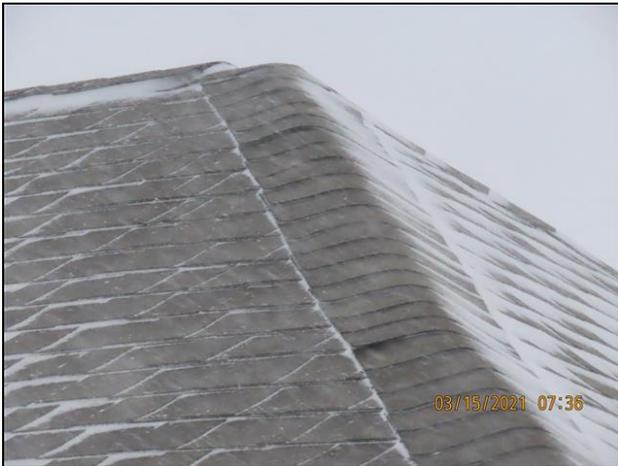
1.0 Item 1(Picture)

- Inspector observed what appeared to be to lifted shingles at the rear of home. Inspector recommends further evaluation once snow melts. This is indication maintenance or repairs may be needed in areas.
- Ensuring shingles are in proper condition will reduce chance of future moisture.

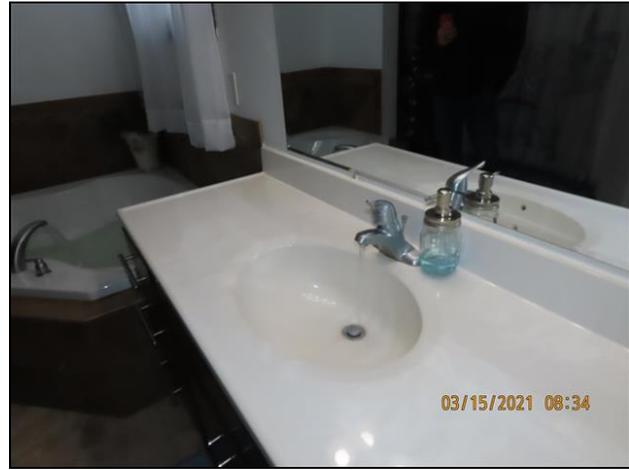
- When the upstairs master bathroom jet tub water source was turned ON.

6.2 Item 2 (Picture) upstairs master bathroom sink - low water pressure when master bathroom jet tub water source was turned ON.

Determining exact cause goes beyond the scope of a home inspection. You may wish to have a qualified plumber further evaluate as desired.

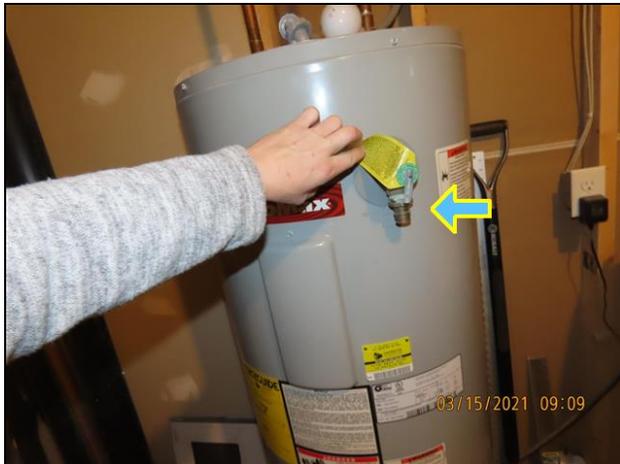
6.3 Item 2 (Picture)

(2) The temperature/pressure relief (TPR) valve had no discharge pipe installed. If the valve were to activate while a person was nearby, injury could occur. The Inspector recommends that a properly-configured TPR discharge pipe be installed by a qualified plumbing contractor. **THE TPR VALVE SHOULD NOT BE TESTED UNTIL A PROPER DISCHARGE PIPE HAS BEEN INSTALLED.**

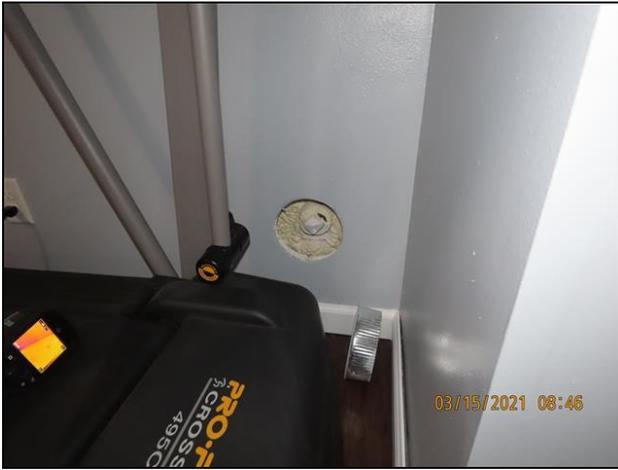
6.7 Item 1(Picture)

- The PVC cap appeared to be sealed shut with foam insulation. Inspector recommends ensuring the cap is accessible as needed. This is a general maintenance item. Replacement caps can be purchased for under \$10 if needed.

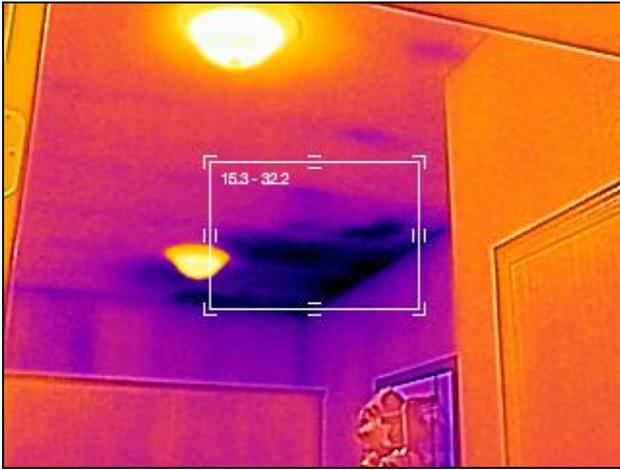
16.0 Item 11(Picture)

- Item 11(Picture) inspector recommends installation in the attic, near the attic access entry, be properly distributed to increase energy efficiency. This is a general maintenance item
